**A RECONNAISSANCE REPORT
ON
THE 2007 SINGKARAK LAKE (SOLOK) EARTHQUAKE
WITH
AN EMPHASIS ON THE SEISMIC ACTIVITY OF SUMATRA FAULT
FOLLOWING 2004 and 2005 GREAT OFF-SUMATRA EARTHQUAKES**

Ömer AYDAN

**Earthquake Disaster Investigation Sub-Committee
Japan Society of Civil Engineers
(Tokai University, Department of Marine Civil Engineering, Shizuoka)**

August 2007

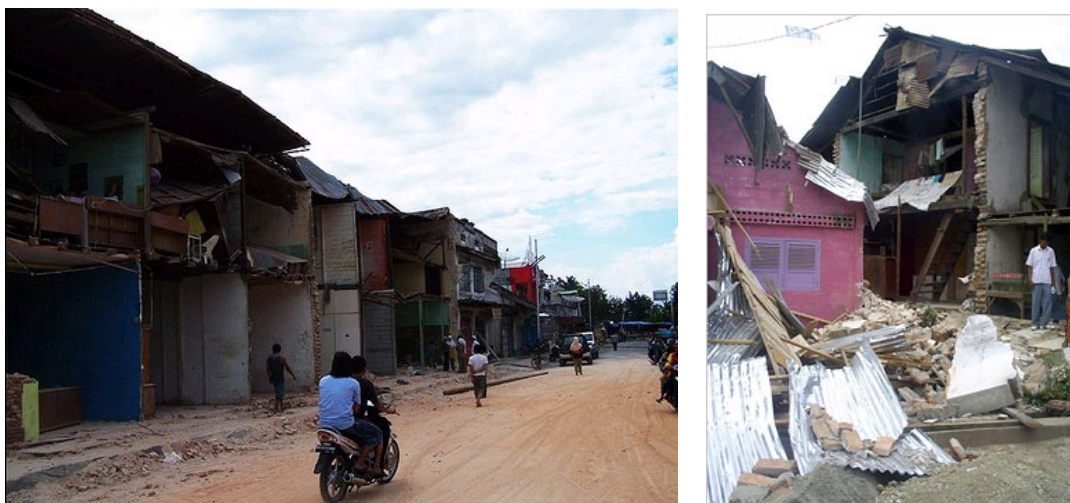
Masonry buildings are generally constructed with bricks and they are either one story or two story buildings. Old masonry buildings has no reinforced concrete lintels and/or columns. Such collapses were observed even in Payakumbuh and Padang, which are relatively far from the epicenter (Figure 5.2) New constructions utilize reinforced concrete slabs and columns. There is no doubt that when such structural elements are integrated with masonry walls they perform better and they prevent the total collapse of the buildings in-spite of some structural damage. The houses or buildings were slightly damaged even they were just on the surface ruptures (Figure 5.3).

Figure 5.2 Collapse of walls of masonry buildings due to out-of-plane loading

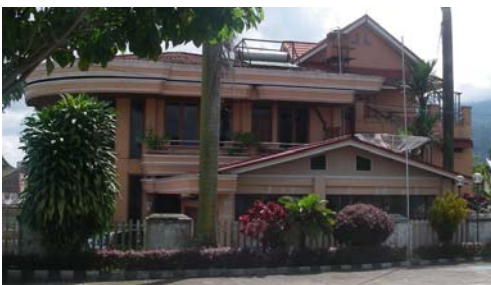
(e) Slightly damaged RC buildings in Padang Panjang

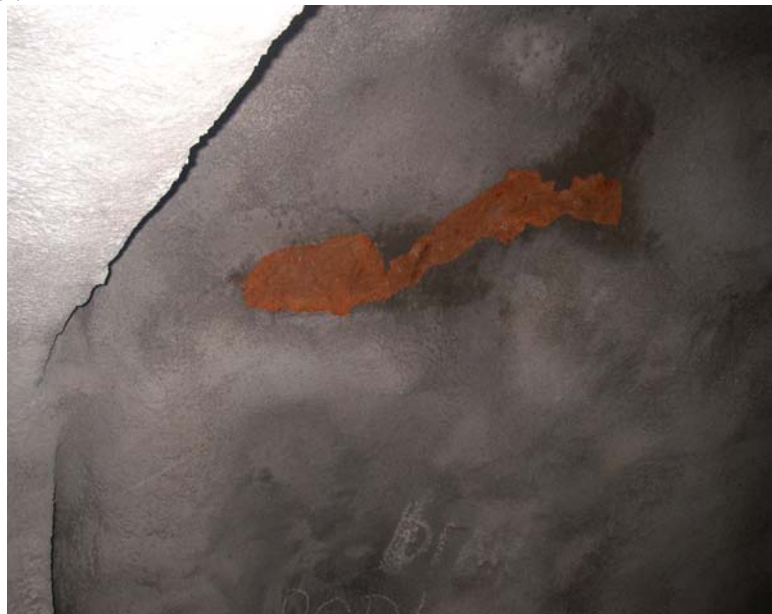
(b) Spalling at Location 3

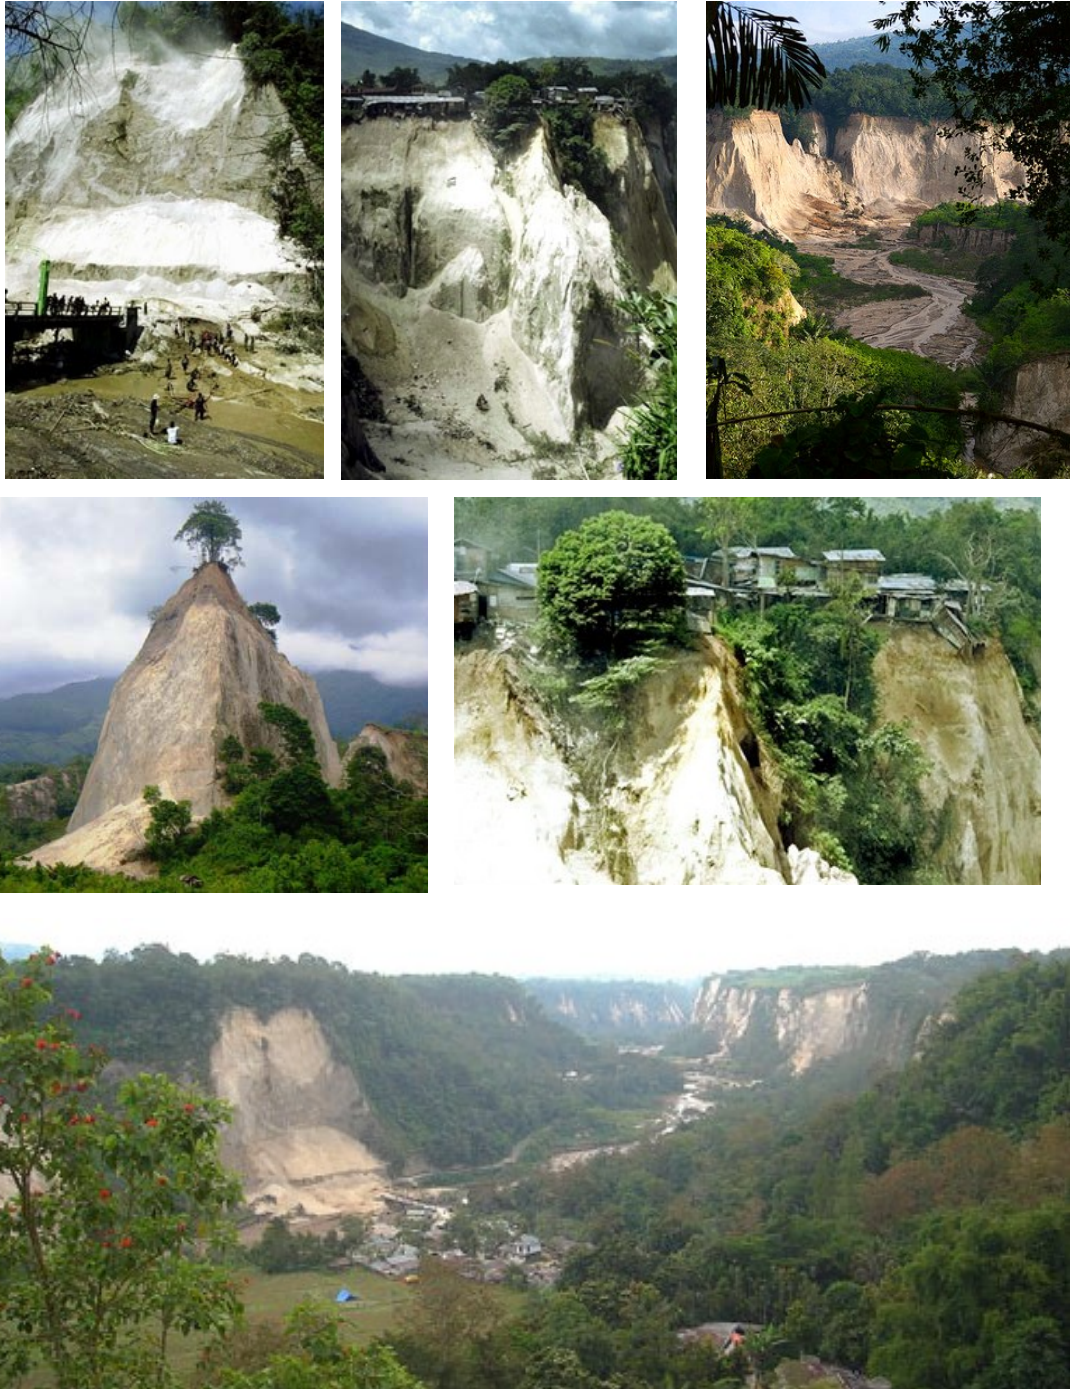
Extensive slope failures observed in Sianok Valley (Figures 8.1 to 8.3). In addition there were also some slope failures and rockfalls in Annai Valley and shore of Singkarark Lake (Figure 8.4). The depth of Sianok Valley is up to 120m and the valley walls are quite steep and the natural slope angles range between $70-80^{\circ}$. The ground mainly consists of pyroclastic flow deposits from nearby Volcanoes as also presented in the previous section. The inclination of the failure plane is about 60° and it is almost planar. The repose angle of the failed ground is about 30° . The material properties of the rock are not well known and it was not measured.

Figure 8.1. Views of slope failures at Sianok Valley in Bukit Tinggi

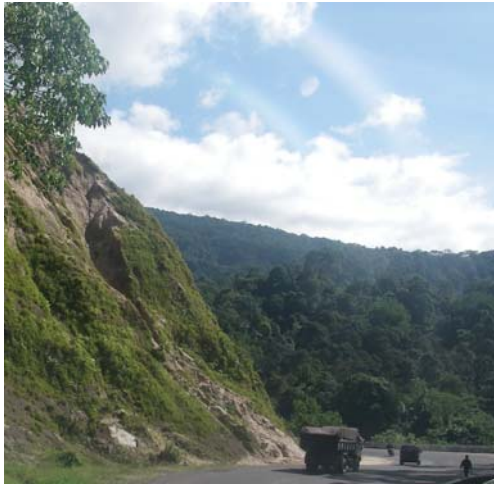
(a) Annai Valley

Figure 8.4. Slope failures and rockfalls

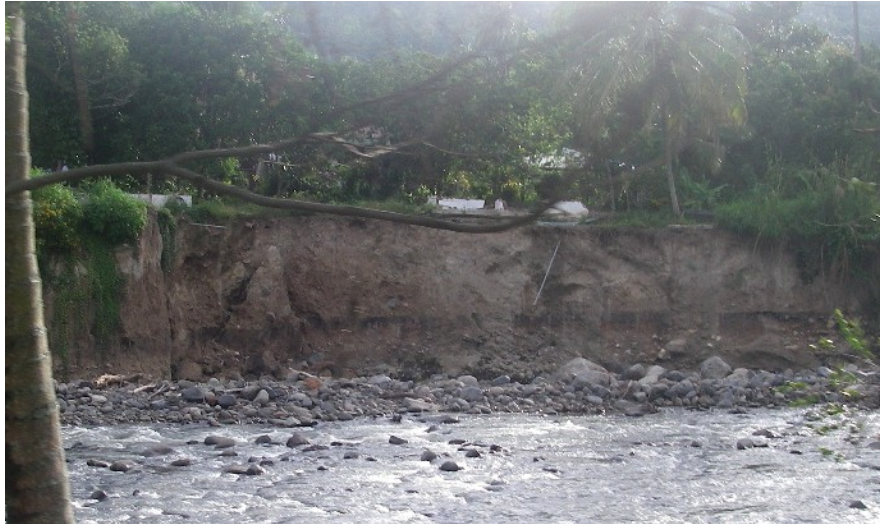
Embankment failures of roadways and rivers were also widespread in the epicentral area (Figures 6.2 and 8.7). The main cause of embankment failures were ground shaking, which resulted in either lateral spreading due to ground liquefaction or curved failure.

(a) Embankment failure at Sumpur Village (the nearest site to the epicenter)

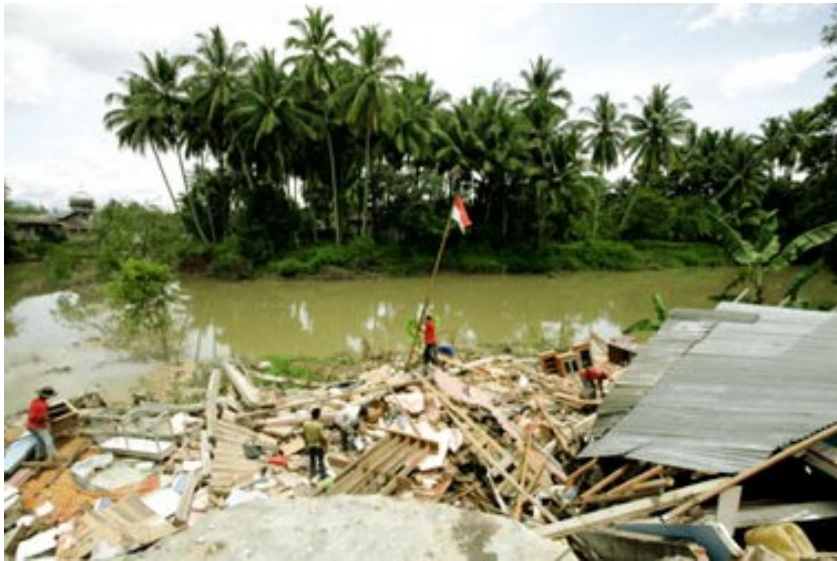
(b) Embankment failure along a river in Solok District
Figure 8.7. Some views of embankment failures
